# MILLPWR<sup>G2</sup> SOFTWARE UPDATE

December 19, 2017  
MILLPWR<sup>G2</sup> 2 & 3 Axis  
Release of Version R4SP7

**For Use with Consoles (ID# 745604-NN) ONLY**

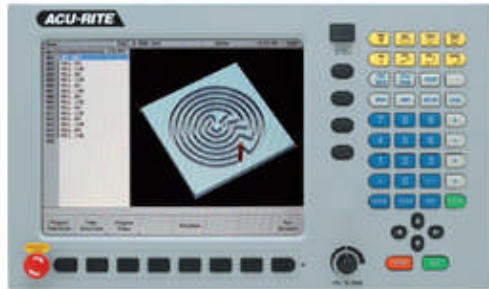
Console ID # 745604-NN

- These consoles **cannot be upgraded to R5** and will continue to receive service packs under the R4 release. Please do not attempt to install release 5 (R5) onto these consoles.

- System drive restructuring on this original design consoles will cause the console to become un-operational and require in house service to correct the issue. **Do not restructure the drive on these consoles.**

- **Not all software enhancements will be included in future R4 releases** . We will continue to support console ID# 745604-NN with service packs through the R4 released software that will mainly include minor enhancements or fixes.

- USB Recovery Drive Kit 1201909-01 includes a compatible USB Recovery Drive ID# 680480-03 for original G2 consoles (ID#745604-NN) and should be ordered when replacing a recovery drive for these consoles. This drive does not include the restructuring option, so the unit cannot be restructured accidentally.
